VOLVO XC60: 1FGE808

Limited Technical Inspection

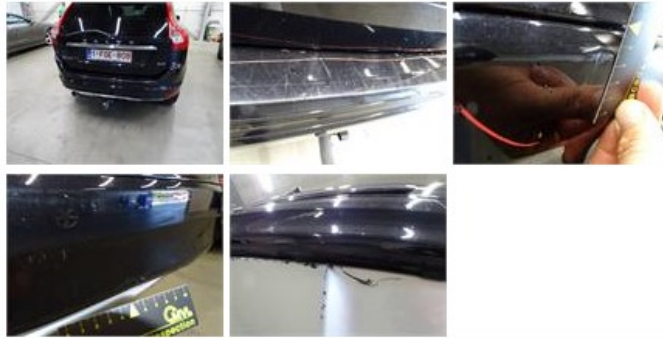
Bumper R, Deformed / Strained, LI - Repair and paint (complete) 302,16

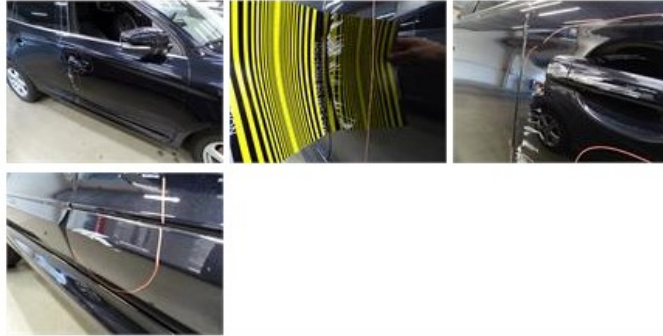
Door F R, Dent(s) and scratch(es), LI - Repair and paint (complete) 430,02

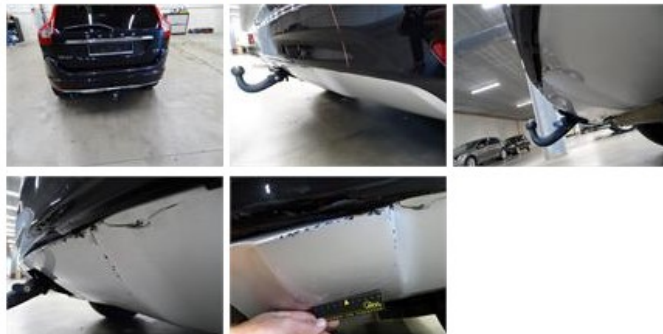
Bumper cover R M, Deformed / Strained, Le - Replace and paint 125,00
