OPEL Zafira: 1GHX532

Limited Technical Inspection

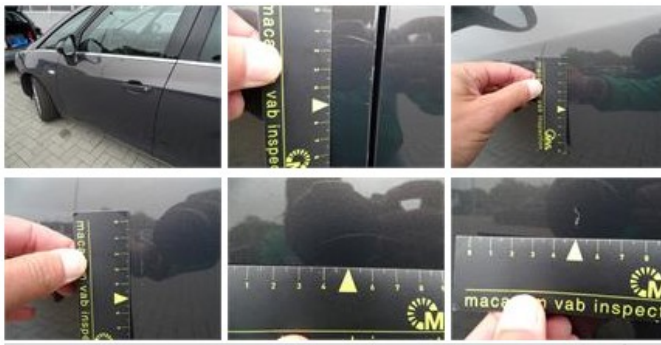
Door F L, Scratch(es), LI - Repair and paint (complete)	318,35
---	---------------

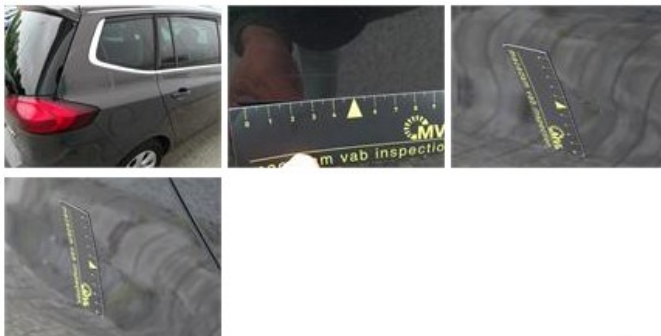
Wing R R, Dent(s), PDR - Knock out without painting 63,00

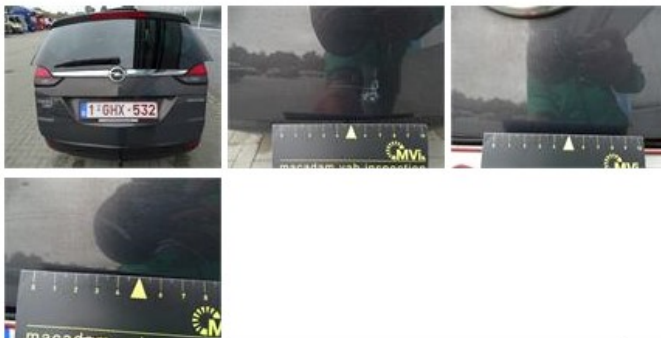
Tailgate, Scratch(es), LI - Repair and paint (complete) 301,68

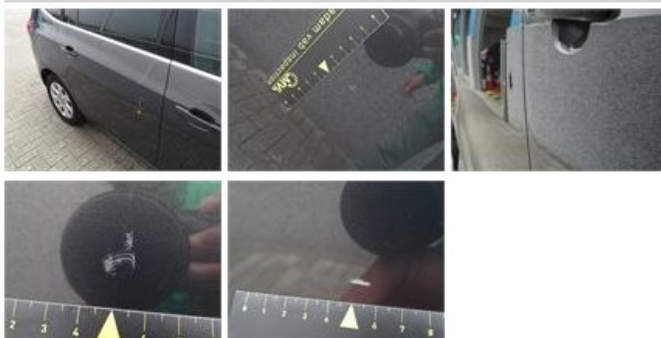
Door R R, Dent(s) and scratch(es), LI - Repair and paint (complete) 318,35
