FORD Galaxy: 1GTU088

Limited Technical Inspection

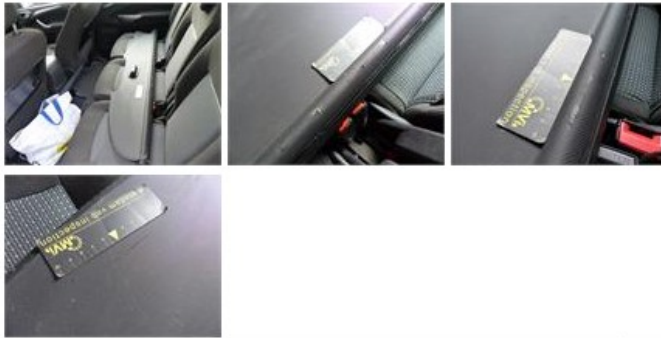
Luggage space cover, Scratch(es), E - Replace 288,00

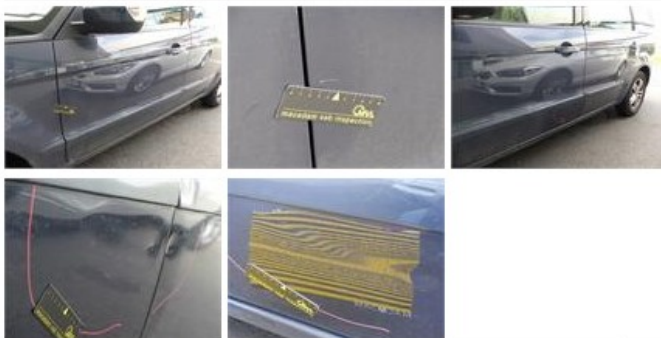
Door F L, Dent(s), LI - Repair and paint (complete) 382,02

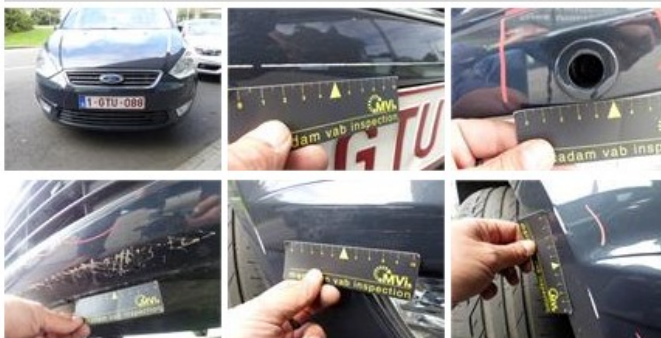
Bumper F, Scratch(es), LI - Repair and paint (complete) 254,16

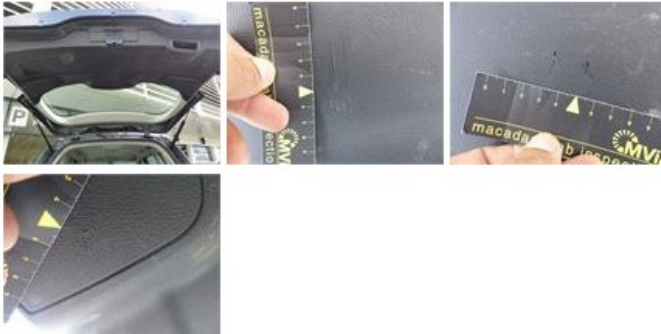
Trunk lid covering R, Scratch(es), Smart repair 110,64

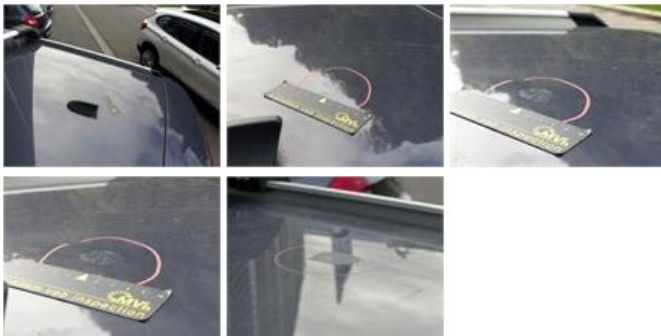
Roof, Chemical pollution, LI - Repair and paint (complete) 577,80

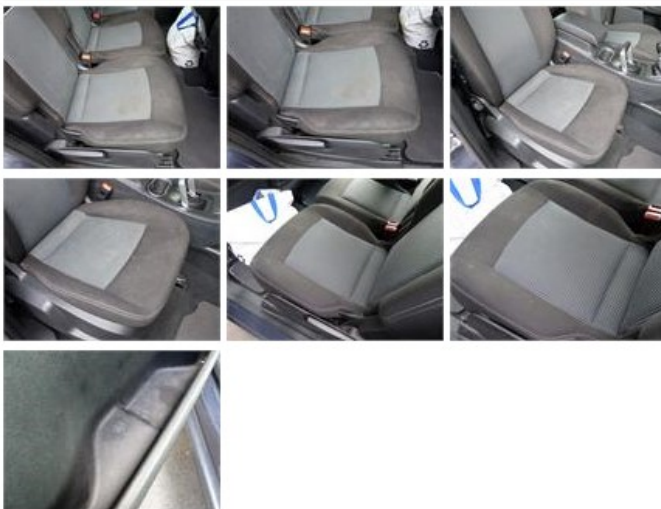
Interior, Dirty, Cleaning 25,00
