BMW 3: 1HHR483

| Vinnumber: | WBA3K11040F828896 | Versionname: | 3 TOURING 318d 136PK |

Limited Technical Inspection

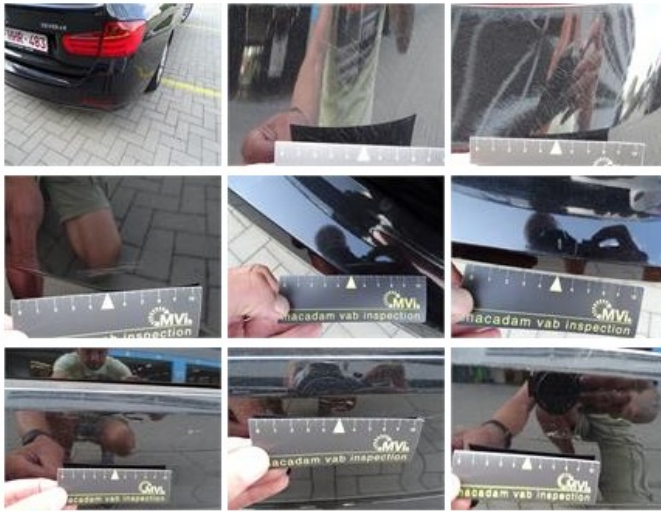
Bumper R, Scratch(es), LI - Repair and paint (complete)

211,80

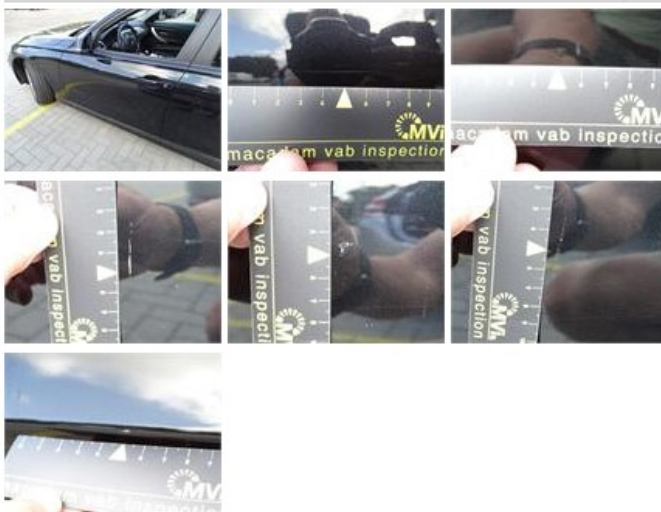
Door F L, Scratch(es), LI - Repair and paint (complete)

318,35
