VOLVO V40: 1FTW164			
Vinnnumber:	<b>YV1MV8481E2106700</b>	Versionname:	<b>V40 D2 Base 115PK</b>
First Registrationdate:	<b>23/10/2013</b>	Fiscalpower:	
Expertise Mileage:	<b>35412</b>	Power Kw:	<b>84</b>
Bodytype:	<b>Break</b>	Body color:	<b>Light Blue</b>
Gearbox:	<b>MAN 6 VIT</b>	Paint type:	<b>Metalic</b>
Transmission:	<b>Front</b>	Rims summer:	<b>Aluminium</b>
Fueltype:	<b>Diesel</b>	Oil level:	<b>OK</b>
Battery functioning:	<b>Yes</b>	Parking lot:	<b>2410</b>
Number of doors:	<b>5</b>		
Number of seats:	<b>5</b>		
Number head rests:	<b>5</b>		
Rims summer:	<b>Aluminium</b>		
Category:	<b>Passenger Car</b>		
Oil level:	<b>OK</b>		
Registration Certificate Car (BE):	<b>Yes</b>

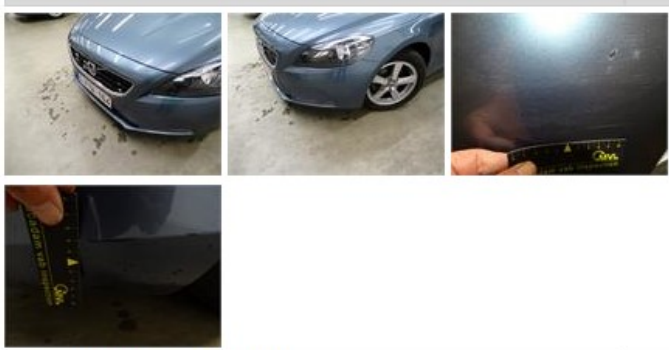
Assistance equipment			
Repair kit	<b>Yes</b>	Compressor	<b>Yes</b>
Total cost ex VAT			<b>496,80</b>
Bumper F, Dent(s), LI - Repair and paint (complete)			<b>211,80</b>
