BMW 5: 1GWN248

Vinnnumber:	WBA5C11020D03928	Versionname:	5 BER 518da 143PK Aut.
First Registrationdate:	20/05/2014	Fiscalpower:	
Expertise Mileage:	129260	Power Kw:	105
Bodytype:		Body color:	Black
Gearbox:	Automatic	Paint type:	Metalic
Transmission:	Back	Rims summer:	Aluminium
Fueltype:	Diesel	Oil level:	OK
Maintenance:	OK	Parking lot:	4228
Maintenance:	IN 17000 KM		
Battery functioning:	Yes		
Number of doors:	4		
Number of seats:	5		
Number head rests:	5		
Rims summer:	Aluminium		
Category:	Passenger Car		
Oil level:	OK		
Registration Certificate Car (BE):	Yes

Limited Technical Inspection

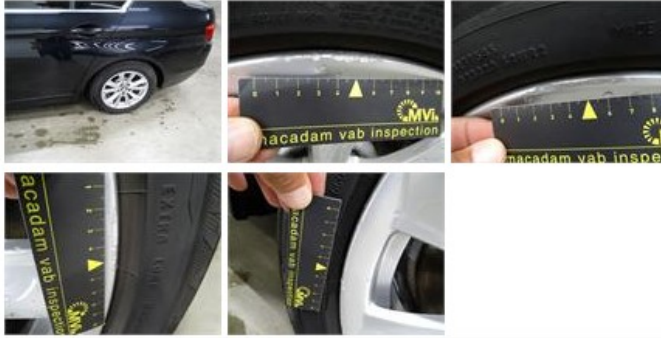
Alloy rim R L, Scratch(es), LI - Repair and paint (complete)

95,00
