**BMW 5: 1JEL976**

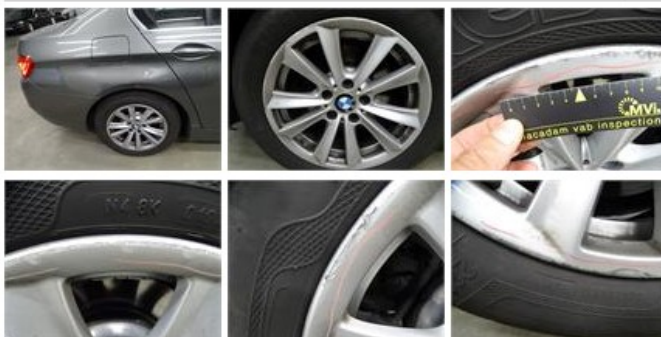
Alloy rim R R, Scratch(es), LI - Repair and paint (complete) 95,00
