**OPEL INSIGNIA SPORTS TOURER: 1JKX458**

**Limited Technical Inspection**

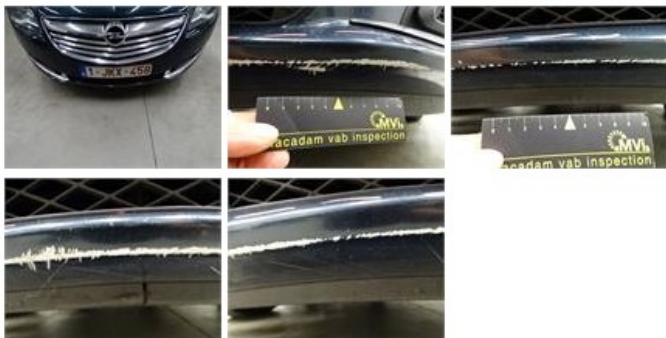
Total cost ex VAT	625,15
Bumper F, Scratch(es), LI - Repair and paint (complete)	211,80
