**MERCEDES A 180: 1FG0041**

**Limited Technical Inspection**

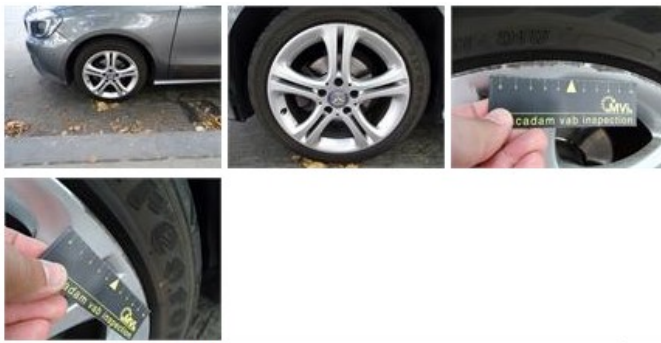
Alloy rim F L, Scratch(es), LI - Repair and paint (complete) 95,00
