LAND ROVER RANGE ROVER EVOQUE: FZ9296

Limited Technical Inspection

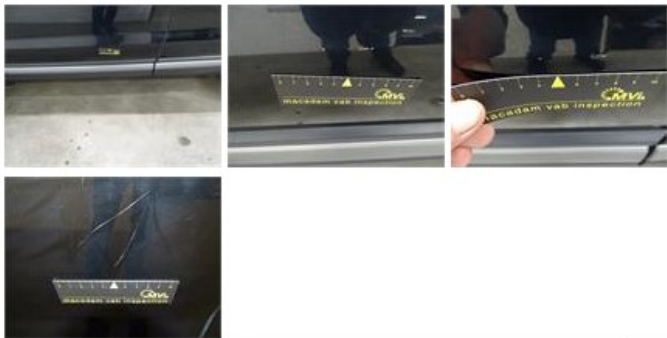
Door F L, Scratch(es), LI - Repair and paint (complete)	382,02
