| <b>BMW 5: 1HFL149</b> | | | |
| Vinnumber: | <b>WBA5J310X0D073644</b> | Versionname: | <b>5 TOURING 520d 163PK</b> |

| <b>Limited Technical Inspection</b> | | | |

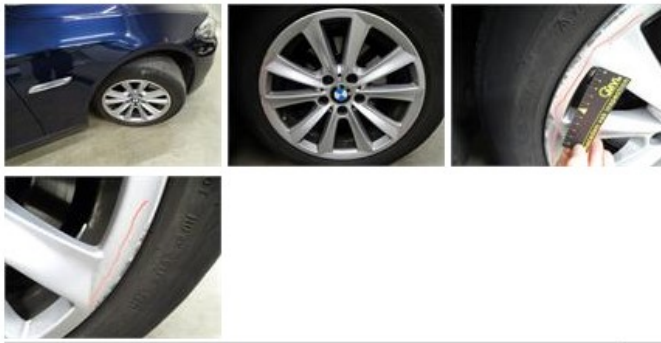
| <b>Alloy rim F R, Scratch(es), I - Repair</b> | <b>100,00</b> |

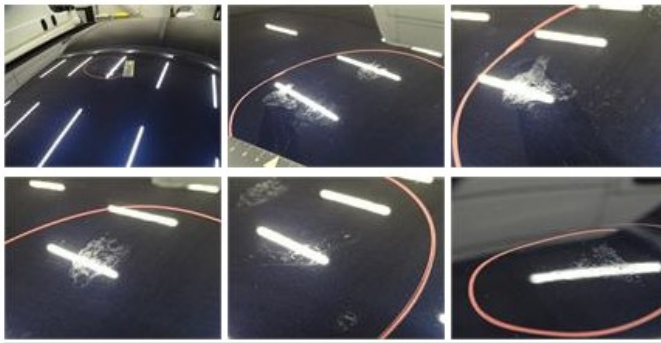
Roof, Chemical pollution, LI - Repair and paint (complete) 577,80
