BMW 3: 1GGX286

Vinnumber:	WBA3K91090F932735	Versionname:	3 TOURING 316d 116PK
First Registrationdate:	5/02/2014	Fiscalpower:	
Expertise Mileage:	99892	Power Kw:	85
Bodytype:		Body color:	Brown
Gearbox:	MAN 6 VIT	Paint type:	Metalic
Transmission:	Back	Rims summer:	Aluminium
Fueltype:	Diesel	Oil level:	OK
Maintenance:	A FAIRE	Parking lot:	2723
Maintenance:	NOT OK		
Battery functioning:	Yes		
Number of doors:	5		
Number of seats:	5		
Number head rests:	5		
Rims summer:	Aluminium		
Category:	Passenger Car		
Oil level:	OK		
Registration Certificate Car (BE):	Yes

Limited Technical Inspection

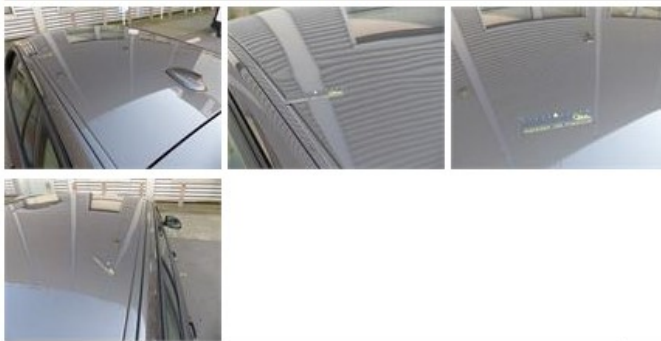
Roof, Dent(s), PDR - Knock out without painting 142,20
