**BMW 3: 1HTZ283**

**Limited Technical Inspection**

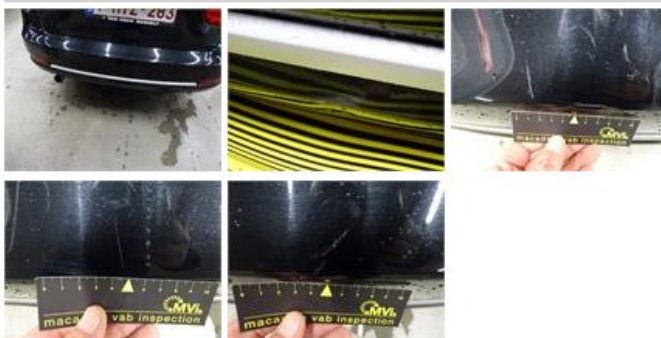
Total cost ex VAT	306,80
Bumper R, Dent(s) and scratch(es), LI - Repair and paint (complete)	211,80
