**BMW 1: 1FGE737**

**Limited Technical Inspection**

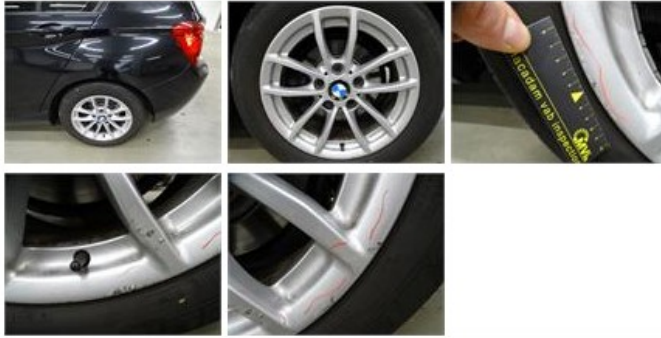
Alloy rim R L, Scratch(es), LI - Repair and paint (complete) 95,00

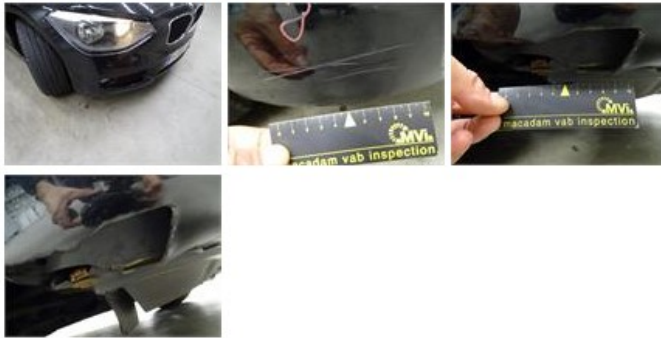
Bumper F, Hole, Le - Replace and paint 735,00
