<b>BMW 1: LA6908</b>			
Vinnumber:	<b>WBA1C11010P530630</b>	Versionname:	<b>1 BER HATCH 118d 143PK</b>
First Registrationdate:	<b>2/12/2014</b>	Fiscalpower:	
Expertise Mileage:	<b>105529</b>	Power Kw:	<b>105</b>
Bodytype:	<b>Hatchback</b>	Body color:	<b>Black</b>
Gearbox:	<b>MAN 6 VIT</b>	Paint type:	<b>Metalic</b>
Transmission:		Rims summer:	<b>Aluminium</b>
Fueltype:	<b>Diesel</b>	Oil level:	<b>OK</b>
Battery functioning:	<b>Yes</b>	Parking lot:	<b>2522</b>
Number of doors:	<b>5</b>		
Number of seats:	<b>5</b>		
Number head rests:	<b>5</b>		
Rims summer:	<b>Aluminium</b>		
Category:	<b>Passenger Car</b>		
Oil level:	<b>OK</b>

<b>Limited Technical Inspection</b>			
Airco functioning	<b>OK</b>	Battery functioning	<b>Yes</b>
Tires wear profile	<b>OK</b>	Power steering	<b>Yes</b>
Idle position	<b>OK</b>	Sound engine	<b>OK</b>
Engine startingtime	<b>OK</b>	Clutch test	<b>OK</b>
Exhaust gass	<b>OK</b>	Wiper fluid level	<b>OK</b>
Handbrake	<b>OK</b>	Transmission	<b>OK</b>
		Lighting	<b>OK</b>
		Wiperblades	<b>NOT OK</b>

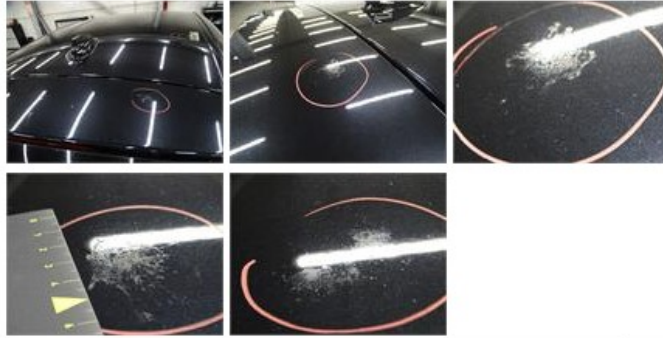
Roof, Chemical polution, LI - Repair and paint (complete) 481,50

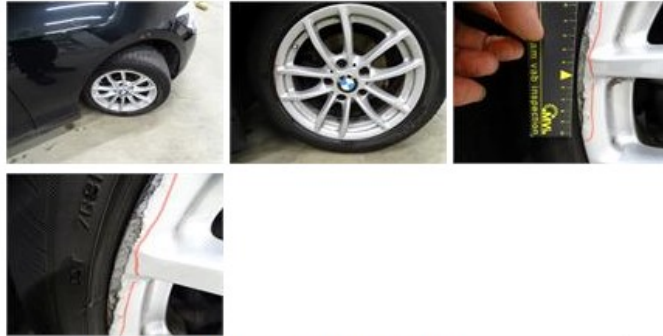
Alloy rim F R, Scratch(es), E - Replace 235,20

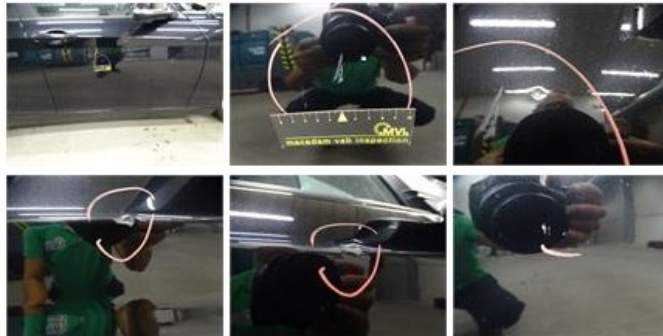
Door F R, Dent(s) and scratch(es), LI - Repair and paint (complete) 318,35

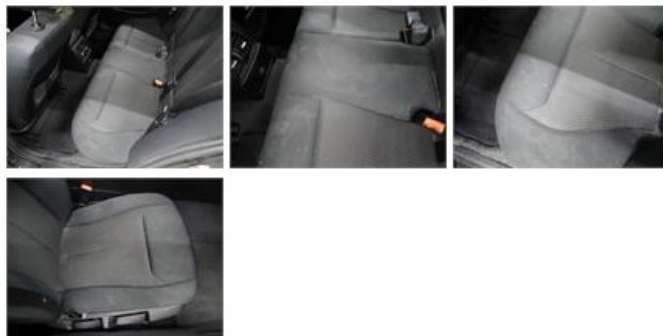
Interior, Dirty, Cleaning 0,00
