**BMW 3: 1HDP225**

**Limited Technical Inspection**

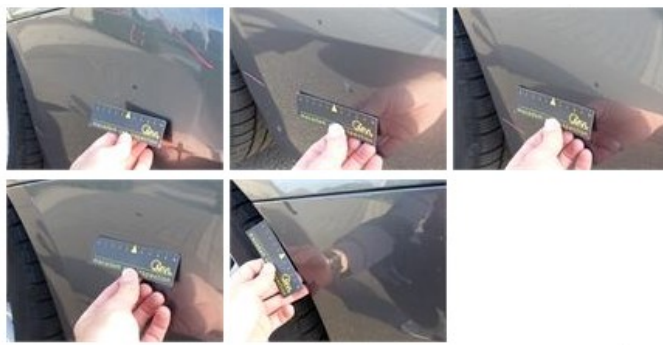
Bumper R, Scratch(es), LI - Repair and paint (complete)	<b>259,80</b>
---------------------------------------------------------	---------------

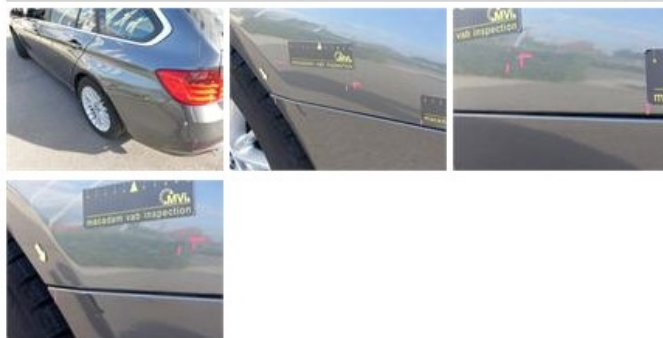
Outer backrest protection L, Scratch(es), Acceptable	0,00
<i>No pictures to display</i>	
Alloy rim F R, Scratch(es), Acceptable	0,00
<i>No pictures to display</i>	
Seat F L compl, Worn, Acceptable	0,00
<i>No pictures to display</i>	
Wing R L, Repaired, Acceptable	0,00
<i>No pictures to display</i>	
Wing R L, Scratch(es), It - Spot repair	115,56

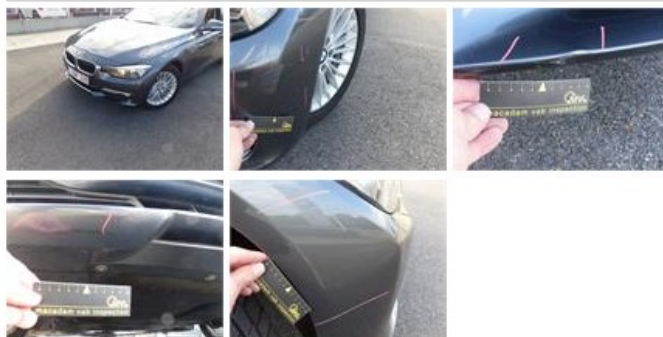
Door R R, Dent(s) and scratch(es), Acceptable	0,00
<i>No pictures to display</i>	
Wing F L, Scratch(es), Acceptable	0,00
<i>No pictures to display</i>	
Door F R, Scratch(es), Acceptable	0,00
<i>No pictures to display</i>	
Outer backrest protection R, Scratch(es), Acceptable	0,00
<i>No pictures to display</i>	
Roof, Chemical pollution, Acceptable	0,00
<i>No pictures to display</i>	
Door F L, Scratch(es), Acceptable	0,00
<i>No pictures to display</i>	
Rear window, Scratch(es), Acceptable	0,00
<i>No pictures to display</i>	
Trunk lid covering R, Scratch(es), Acceptable	0,00
<i>No pictures to display</i>	
Bumper F, Dent(s) and scratch(es), LI - Repair and paint (complete)	283,80
