**MERCEDES E: 1HHK269**

| Vinnnumber: | <b>WDD2120051B061047</b> | Versionname: | <b>E BER 200CDI BE 136PK</b> |

**Limited Technical Inspection**

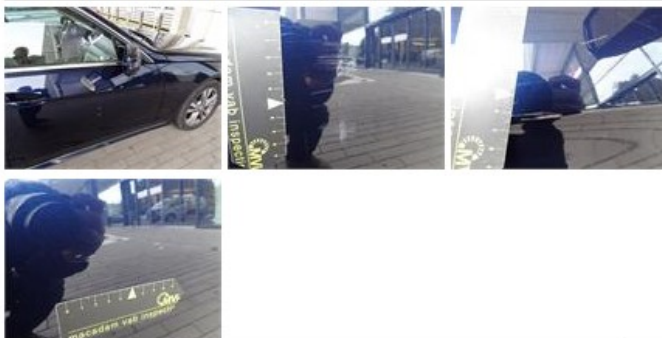
Door F R, Scratch(es), LI - Repair and paint (complete) 382,02
