MERCEDES A: 1GIV687			
Vinnumber:	WDD1760121J245887	Versionname:	A 180 CDI BE 109PK
First Registrationdate:	19/02/2014	Fiscalpower:	
Expertise Mileage:	72828	Power Kw:	80
Bodytype:		Body color:	Grey
Gearbox:	MAN 6 VIT	Paint type:	Metalic
Transmission:	Front	Rims summer:	Aluminium
Fueltype:	Diesel	Oil level:	OK
Battery functioning:	Yes	Parking lot:	3503
Number of doors:	5		
Number of seats:	5		
Number head rests:	1		
Rims summer:	Aluminium		
Category:	Passenger Car		
Oil level:	OK		
Registration Certificate Car (BE):	Yes

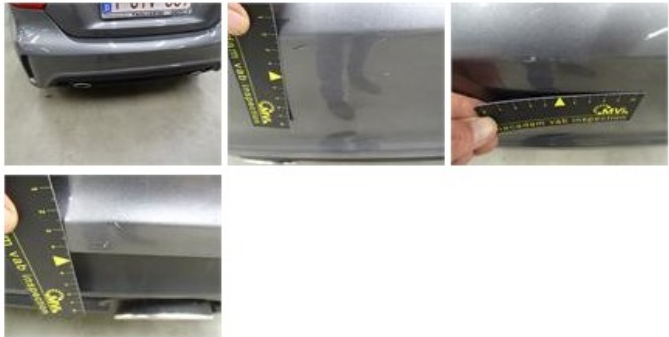
Assistance equipment			
Repair kit	Yes	Compressor	Yes
Total cost ex VAT			803,60
Bumper R, Dent(s) and scratch(es), LI - Repair and paint (complete)			211,80
