**OPEL Zafira: 1HBR431**

**Limited Technical Inspection**

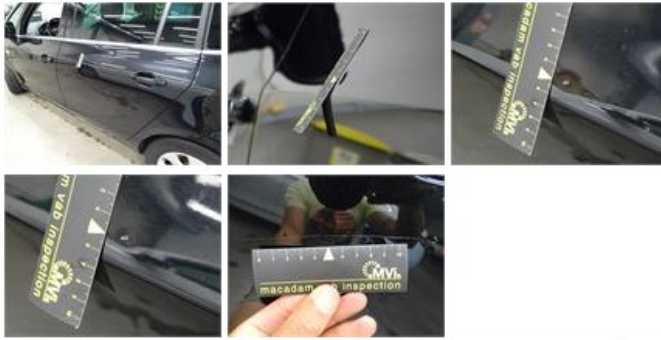
Door R L, Dent(s) and scratch(es), LI - Repair and paint (complete) 318,35

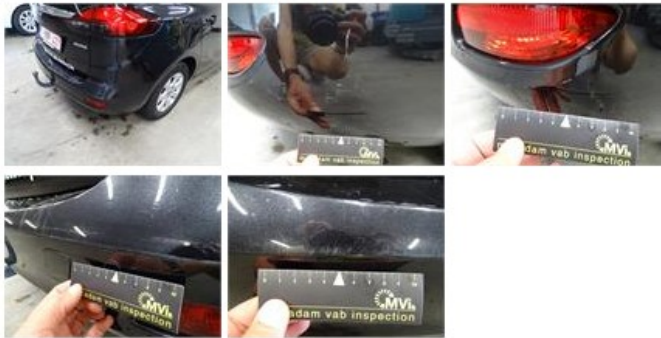
Bumper R, Scratch(es), LI - Repair and paint (complete) 211,80
