SKODA Superb: 1HTC477

Limited Technical Inspection

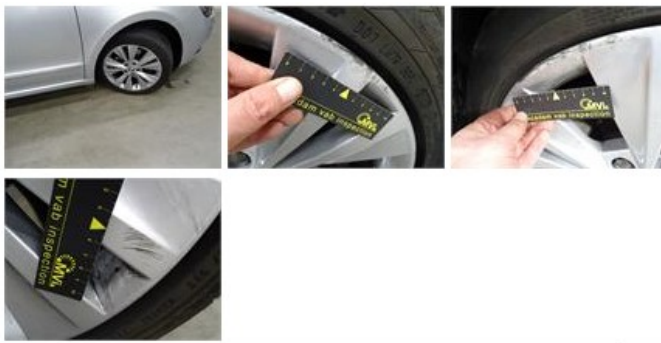
Alloy rim F R, Scratch(es), LI - Repair and paint (complete)	95,00
--	--------------

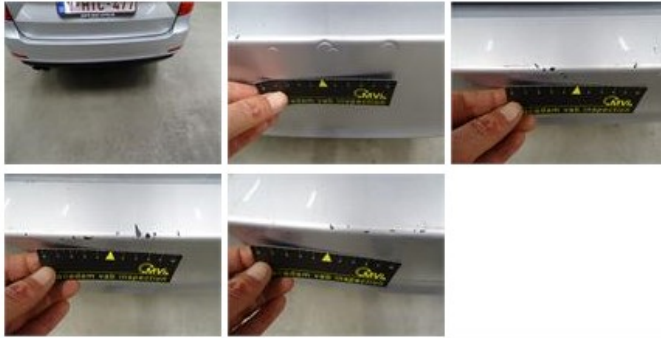
Bumper R, Scratch(es), LI - Repair and paint (complete) 254,16
