**BMW 3: 1EXW892**

**Limited Technical Inspection**

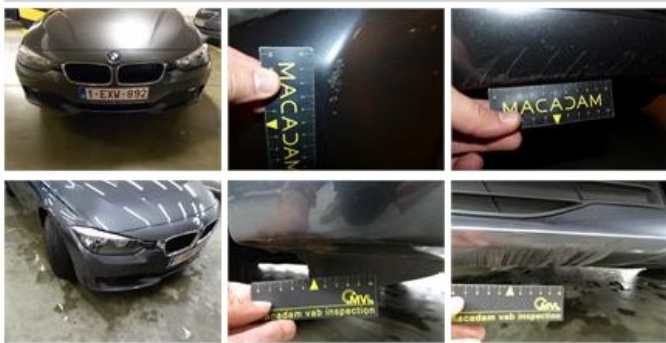
Bumper F, Scratch(es), LI - Repair and paint (complete)	<b>211,80</b>
---	---------------
