FORD S-MAX: 1ANF036

Limited Technical Inspection

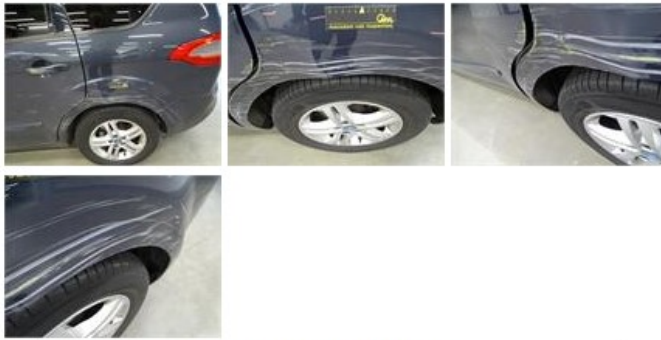
Wing R L, Dent(s) and scratch(es), Le - Replace and paint 1429,81

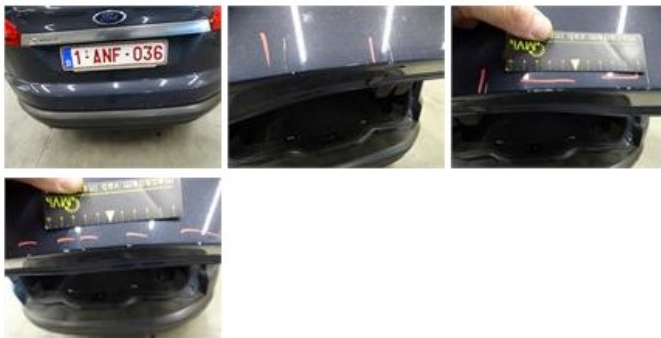
Tailgate, Scratch(es), LI - Repair and paint (complete) 362,02

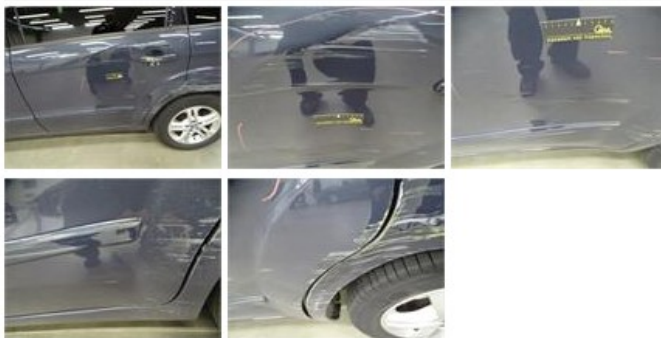
Door R L, Dent(s) and scratch(es), Le - Replace and paint 1107,49

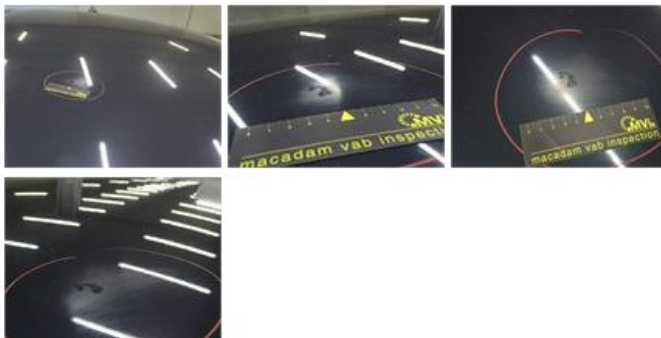
Roof, Scratch(es), LI - Repair and paint (complete) 577,80
