<b>BMW 3: VB9655</b>			
Vinnnumber:	<b>WBA3Z51030D398583</b>	Versionname:	<b>3 GRAN TURISMO 330dXA</b>
First Registrationdate:	<b>18/09/2014</b>	Fiscalpower:	<b>258PK Aut.</b>
Expertise Mileage:	<b>135020</b>	Power Kw:	<b>190</b>
Bodytype:		Body color	<b>Black</b>
Gearbox:	<b>Automatic</b>	Paint type	<b>Metalic</b>
Transmission:		Rims summer	<b>Aluminium</b>
Fueltype:	<b>Diesel</b>	Oil level	<b>OK</b>
Battery functioning	<b>Yes</b>	Parking lot	<b>3805</b>
Number of doors	<b>5</b>		
Number of seats	<b>5</b>		
Number head rests	<b>5</b>		
Rims summer	<b>Aluminium</b>		
Category	<b>Passenger Car</b>		
Oil level	<b>OK</b>

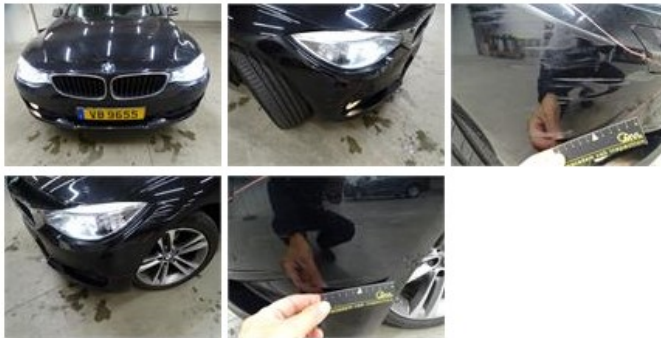
Bumper F, Scratch(es), LI - Repair and paint (complete) 211,80
