MAZDA 3: 1HEZ685			
Vinnumber:	<b>JMZBM622611154302</b>	Versionname:	<b>3 SED Sense 150PK</b>
First Registrationdate:	<b>4/07/2014</b>	Fiscalpower:	
Expertise Mileage:	<b>201475</b>	Power Kw:	<b>110</b>
Bodytype:		Body color:	<b>Red</b>
Gearbox:	<b>MAN 6 VIT</b>	Paint type:	<b>Metalic</b>
Transmission:		Rims summer:	<b>Aluminium</b>
Fueltype:	<b>Diesel</b>	Oil level:	<b>OK</b>
Battery functioning:	<b>Yes</b>	Parking lot:	<b>3110</b>
Number of doors:	<b>4</b>		
Number of seats:	<b>5</b>		
Number head rests:	<b>5</b>		
Rims summer:	<b>Aluminium</b>		
Category:	<b>Passenger Car</b>		
Oil level:	<b>OK</b>		
Registration Certificate Car (BE):	<b>Yes</b>

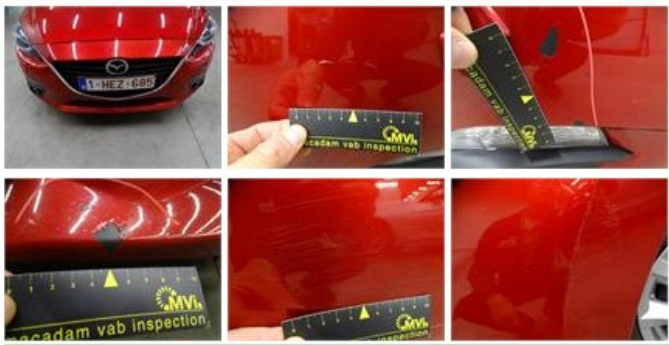
Total cost ex VAT	<b>725,28</b>
Bumper F, Scratch(es), LI - Repair and paint (complete)	<b>211,80</b>

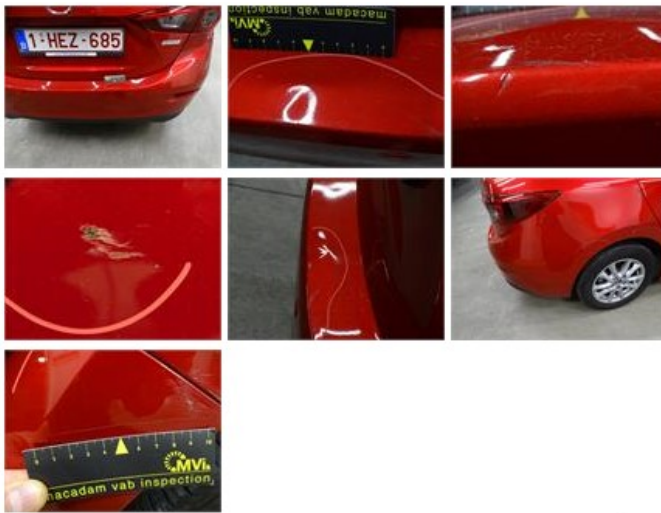
Bumper R, Dent(s) and scratch(es), LI - Repair and paint (complete)	<b>211,80</b>
---	---------------

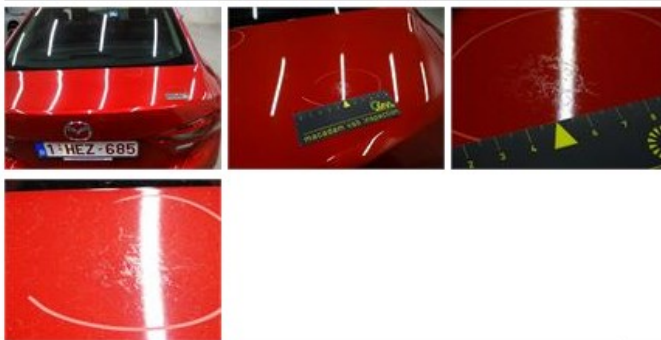
Maintenance book, Missing, E - Replace	0,00
<i>No pictures to display</i>	
Sill outer R, Dent(s), Acceptable	0,00
<i>No pictures to display</i>	
Tailgate, Chemical polution, LI - Repair and paint (complete)	301,68
