MERCEDES A: 1HJK312

Limited Technical Inspection

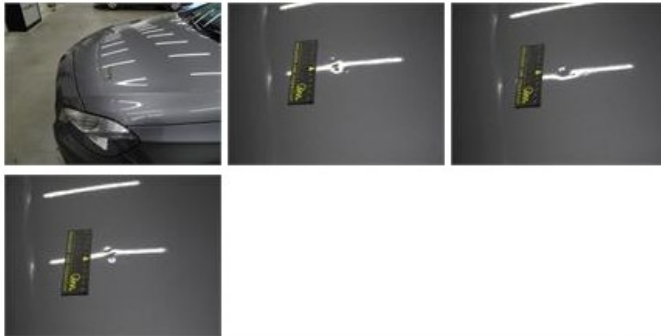
Bonnet, Dent(s), PDR - Knock out without painting 63,00

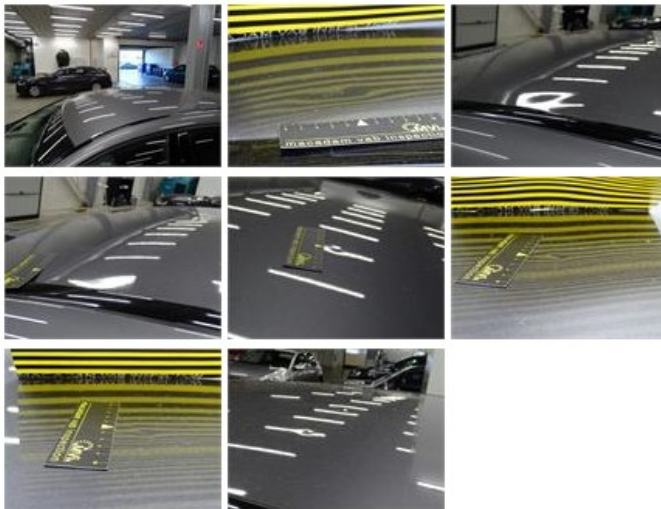
Roof, Dent(s), LI - Repair and paint (complete) 481,50
