VOLKSWAGEN Golf: 1FPQ760

Limited Technical Inspection

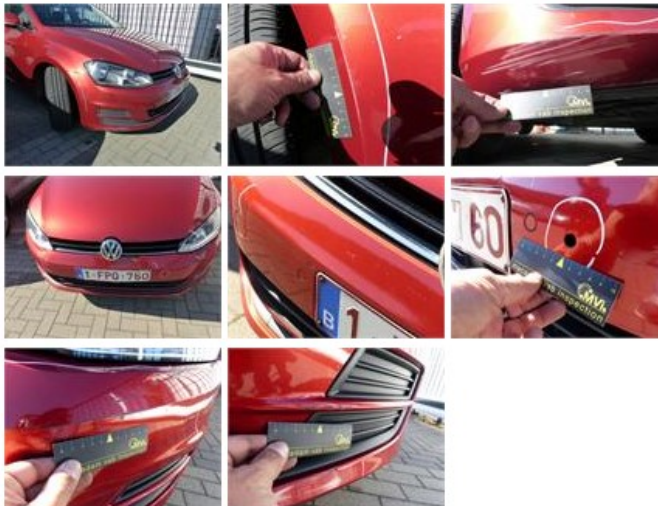
Bumper F, Hole, Le - Replace and paint 0,00
