**LU Volkswagen Golf: VV7980**

Vinnumber:	<b>WVWZZAUZHP318614</b>	Versionname:	<b>1.4 TSI 110kW Highline</b>
First Registrationdate:	<b>11/04/2017</b>	Fiscalpower:	
Expertise Mileage:	<b>31156</b>	Power Kw:	<b>110</b>
Bodytype:	<b>Hatchback</b>	Body color:	<b>Black</b>
Gearbox:	<b>MAN 6 VIT</b>	Paint type:	<b>Metalic</b>
Transmission:	<b>Front</b>	Rims summer:	<b>Aluminium</b>
Fueltype:	<b>Petrol</b>	Oil level:	<b>OK</b>
Battery functioning:	<b>Yes</b>	Parking lot:	<b>3528</b>
Number of doors:	<b>5</b>		
Number of seats:	<b>5</b>		
Number head rests:	<b>5</b>		
Rims summer:	<b>Aluminium</b>		
Category:	<b>Passenger Car</b>		
Oil level:	<b>OK</b>		
Registration Certificate Car (BE):	<b>Yes</b>

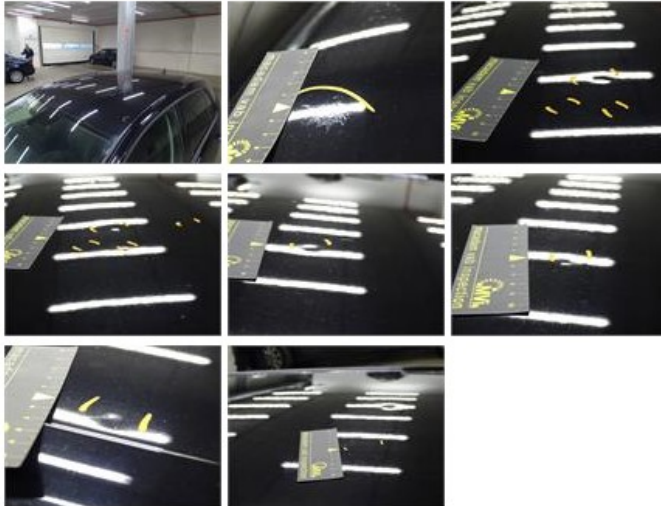
Roof, Chemical pollution, LI - Repair and paint (complete) 625,50

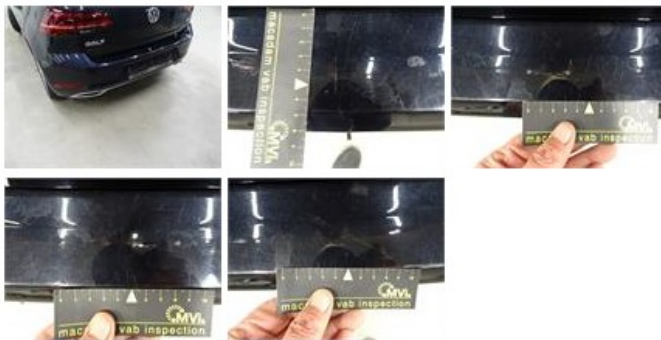
Bumper R, Scratch(es), LI - Repair and paint (complete) 211,80

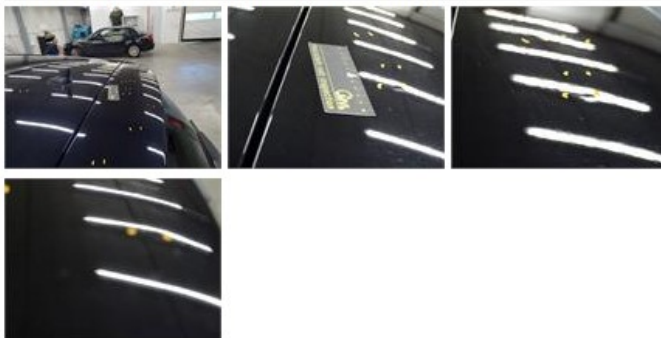
Tailgate, Hail damage, LI - Repair and paint (complete) 301,68
