## VOLKSWAGEN TIGUAN: 1DUR320

| Vinnnumber: | <b>WVGZZ5NZDW018673</b> | Versionname: | <b>TIGUAN Trend&amp;Fun BM Tech.110PK</b> |

## Limited Technical Inspection

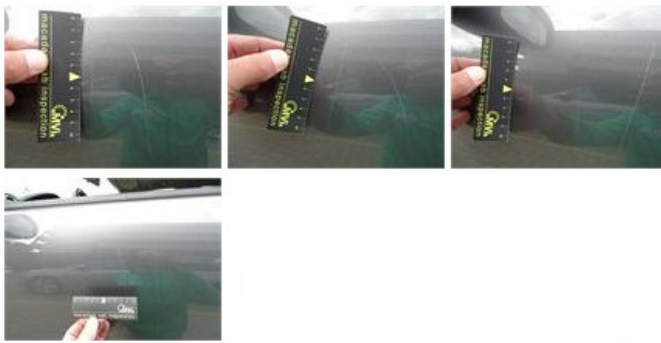
| Door F L, Dent(s) and scratch(es), LI - Repair and paint (complete) | 318,35 |

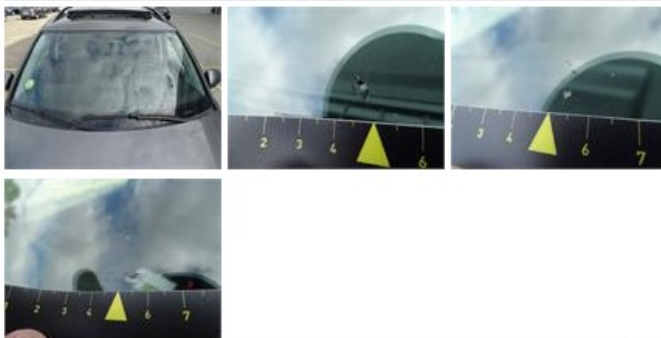
Windscreen, Stone chip(s), Windscreen repair 0,00
