VOLKSWAGEN Golf: 1GIL152			
Vinnnumber:	<b>WVWZZZ1KZEK004837</b>	Versionname:	<b>GOLF CABRIO BMT 105PK</b>
First Registrationdate:	<b>17/02/2014</b>	Fiscalpower:	
Expertise Mileage:	<b>68843</b>	Power Kw:	<b>77</b>
Bodytype:	<b>Cabriolet</b>	Body color:	<b>Black</b>
Gearbox:	<b>MAN 5 VIT</b>	Paint type:	<b>Metalic</b>
Transmission:	<b>Front</b>	Rims summer:	<b>Aluminium</b>
Fueltype:	<b>Diesel</b>	Oil level:	<b>OK</b>
Battery functioning:	<b>Yes</b>	Parking lot:	<b>3109</b>
Number of doors:	<b>2</b>		
Number of seats:	<b>4</b>		
Number head rests:	<b>4</b>		
Rims summer:	<b>Aluminium</b>		
Category:	<b>Passenger Car</b>		
Oil level:	<b>OK</b>		
Registration Certificate Car (BE):	<b>Yes</b>

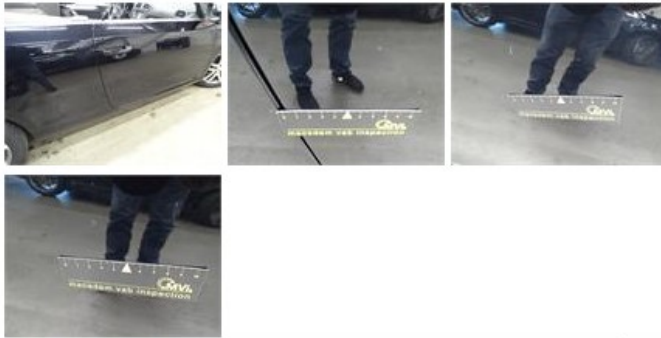
Door F L, Scratch(es), LI - Repair and paint (complete) 0,00
