BMW 3: 1HLY435

Limited Technical Inspection

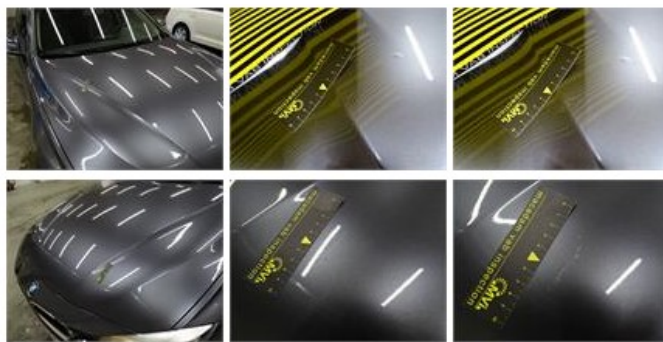
Bonnet, Chemical polution, LI - Repair and paint (complete)

290,08
