| MERCEDES B: 1FSY383 | | | |
| Vinnnumber: | WDD2462121J211603 | Versionname: | B 180 CDI BE 109PK |

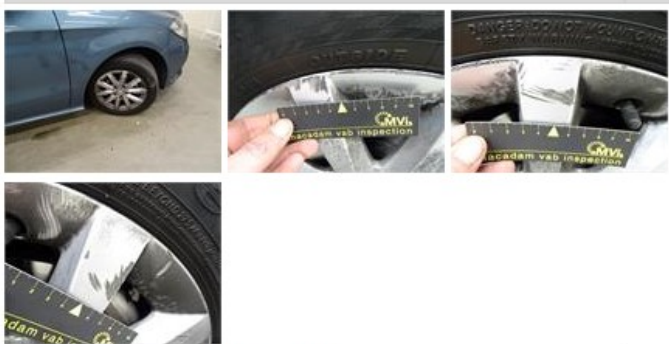
| Bumper R, Crack, Le - Replace and paint | 651,00 |

| | | Wing R R, Dent(s) and scratch(es), LI - Repair and paint (complete) | 308,20 |
| | | Door R R, Dent(s) and scratch(es), LI - Repair and paint (complete) | 318,35 |
| | | Alloy rim R R, Scratch(es), LI - Repair and paint (complete) | 95,00 |
| | | Bumper moulding R L, Missing, E - Replace | 14,40 |
| | | Sill outer R, Scratch(es), Acceptable | 0,00 |
