| SKODA Octavia: 1HFB560 | | | |
| Vinnnumber: | TMBJG7NE5E0228127 | Versionname: | OCTAVIA COMBI Ambition |
| Limited Technical Inspection | | | |

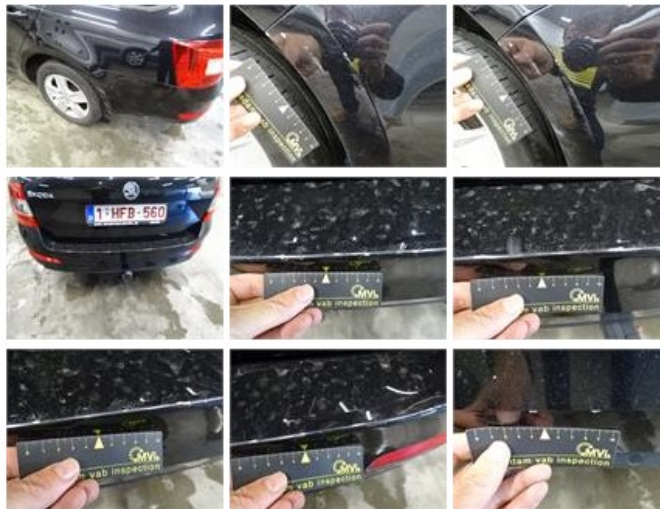
Bumper R, Scratch(es), LI - Repair and paint (complete)

211,80

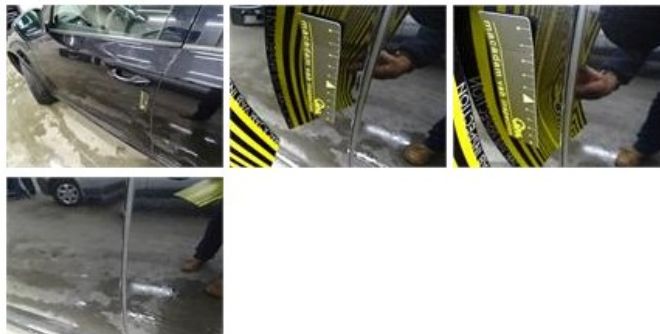
Door F L, Dent(s) and scratch(es), LI - Repair and paint (complete)

318,35

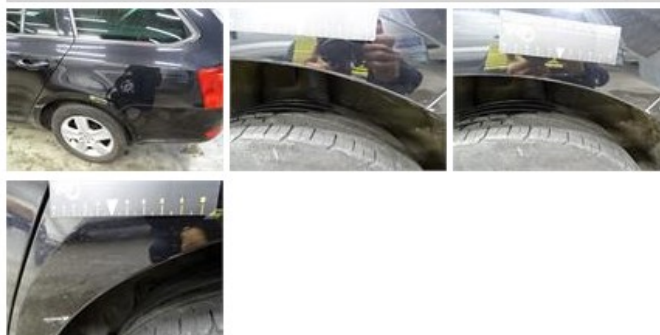
Wing R L, Scratch(es), LI - Repair and paint (complete)

308,20
