**SKODA Octavia: 1DGG298**

**Limited Technical Inspection**

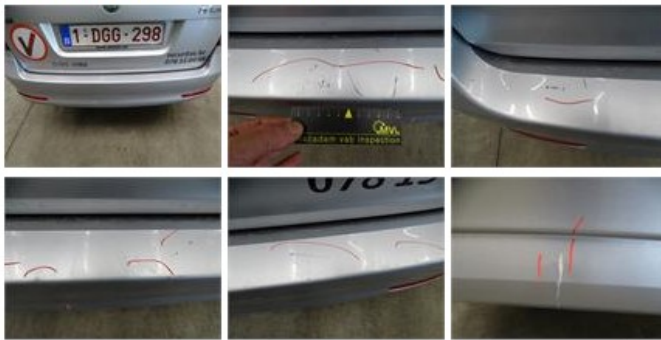
| Bumper R, Scratch(es), LI - Repair and paint (complete) | 211,80 |
