## VOLKSWAGEN TIGUAN: 1FPV311

Vinnnumber:	<b>WVGZZZ5NZEW031376</b>	Versionname:	<b>TIGUAN Trend&amp;Fun BM Tech.110PK</b>
First Registrationdate:	<b>18/09/2013</b>	Fiscalpower:	
Expertise Mileage:	<b>177600</b>	Power Kw:	<b>81</b>
Bodytype:	<b>SUV</b>	Body color:	<b>Beige</b>
Gearbox:	<b>MAN 6 VIT</b>	Paint type:	<b>Metalic</b>
Transmission:		Rims summer:	<b>Aluminium</b>
Fueltype:	<b>Diesel</b>	Oil level:	<b>OK</b>
Battery functioning:	<b>Yes</b>	Parking lot:	<b>4807</b>
Number of doors:	<b>5</b>		
Number of seats:	<b>5</b>		
Number head rests:	<b>5</b>		
Rims summer:	<b>Aluminium</b>		
Category:	<b>Passenger Car</b>		
Oil level:	<b>OK</b>		
Registration Certificate Car (BE):	<b>Yes</b>

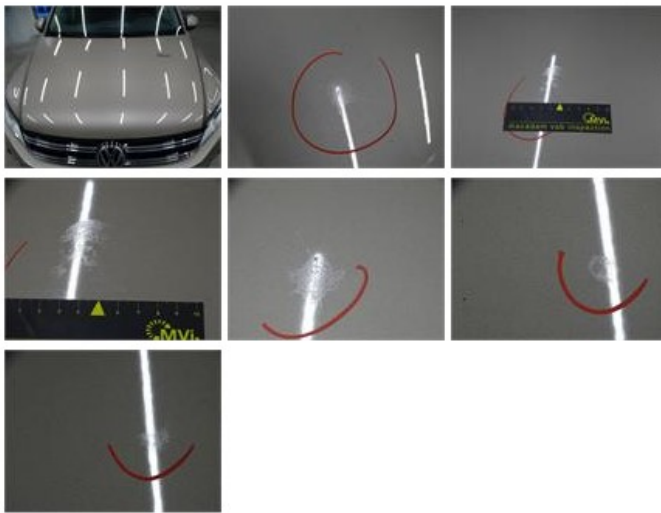
Repair kit	<b>Yes</b>	Compressor	<b>Yes</b>
Total cost ex VAT			<b>290,08</b>
Alloy rim R L, Scratch(es), Acceptable			<b>0,00</b>
<i>No pictures to display</i>			
Bumper F R, Scratch(es), Acceptable			<b>0,00</b>
<i>No pictures to display</i>			
Door R R, Scratch(es), 67 - Polish			<b>0,00</b>
<i>No pictures to display</i>			
Door F R, Scratch(es), Acceptable			<b>0,00</b>
<i>No pictures to display</i>			
Floor covering F L, Worn, Acceptable			<b>0,00</b>
<i>No pictures to display</i>			
Bonnet, Chemical polution, LI - Repair and paint (complete)			<b>290,08</b>
