MERCEDES C: 1G1S046

Limited Technical Inspection

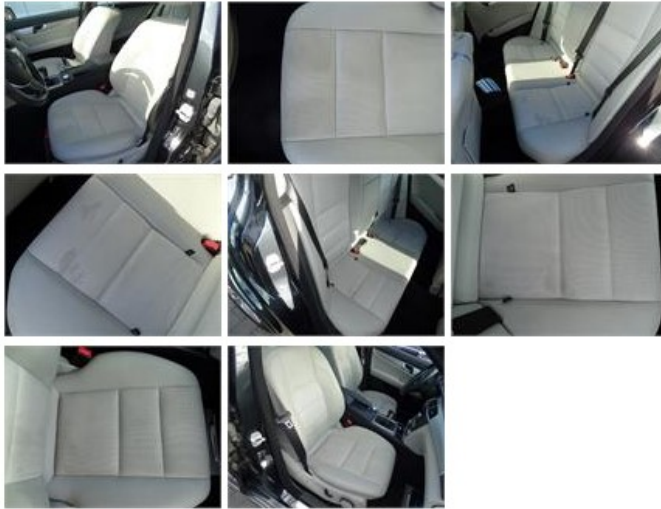
Interior, Stain, Cleaning 100,00
