OPEL Insignia: 1FRR629

Limited Technical Inspection

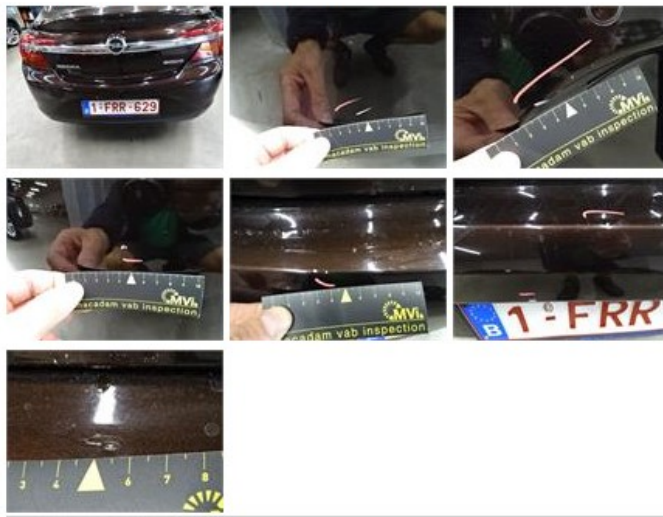
Bumper R, Scratch(es), LI - Repair and paint (complete)	211,80
---	--------

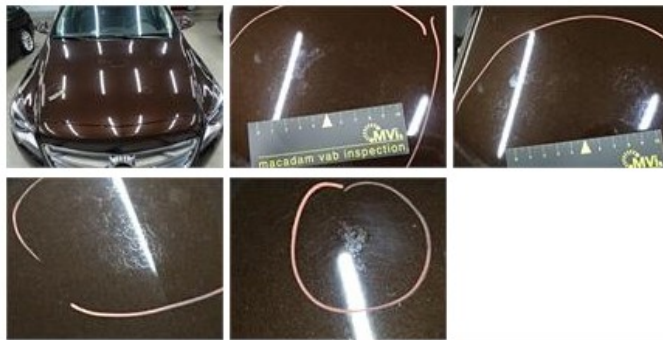
Bonnet, Chemical polution, LI - Repair and paint (complete) 290,08

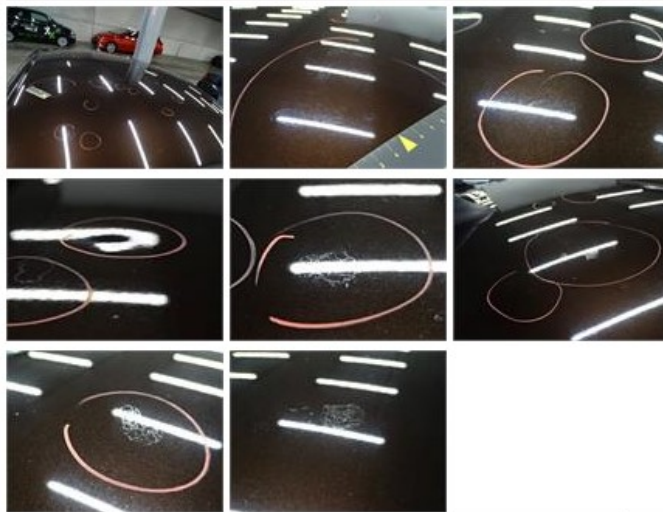
Roof, Chemical polution, LI - Repair and paint (complete) 481,50

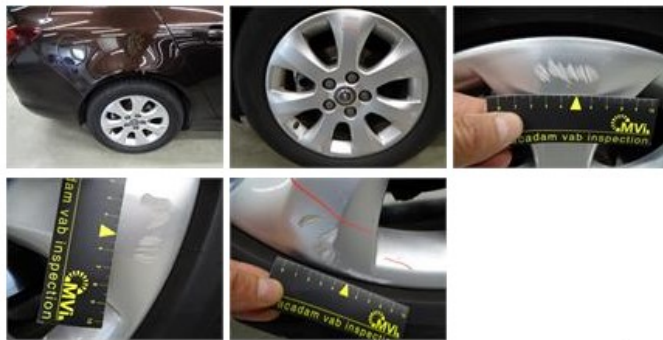
Alloy rim R R, Scratch(es), LI - Repair and paint (complete) 95,00
