**BMW 3: 1FTQ529**

**Limited Technical Inspection**

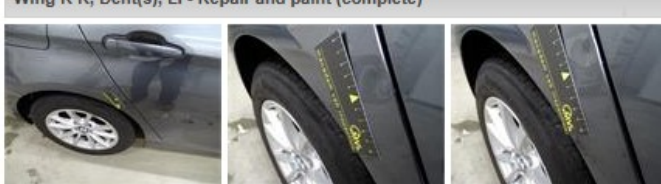
Wing R R, Dent(s), LI - Repair and paint (complete) 308,20
