**BMW 5: 1FOV823**

**Limited Technical Inspection**

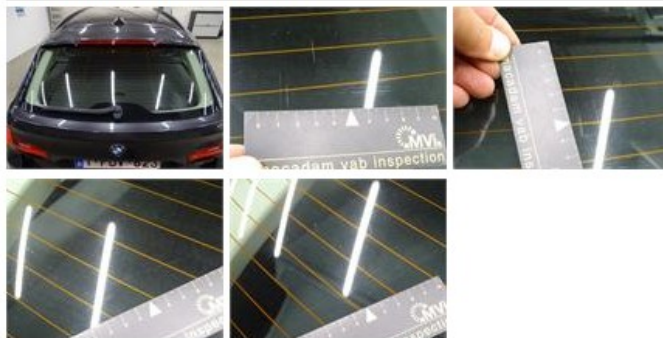
Rear window, Scratch(es), E - Replace
