MERCEDES A: 1GHT325

Vinnumber:	WDD1760111J230795	Versionname:	A 160 CDI 90PK
First Registrationdate:	11/02/2014	Fiscalpower:	
Expertise Mileage:	69109	Power Kw:	66
Bodytype:		Body color:	Grey
Gearbox:	MAN 6 VIT	Paint type:	Metalic
Transmission:	Front	Rims summer:	Steel
Fueltype:	Diesel	Oil level:	OK
Maintenance:	OK	Parking lot:	3705
Battery functioning:	Yes		
Number of doors:	5		
Number of seats:	5		
Number head rests:	5		
Rims summer:	Steel		
Category:	Passenger Car		
Oil level:	OK		
Registration Certificate Car (BE):	Yes

Limited Technical Inspection

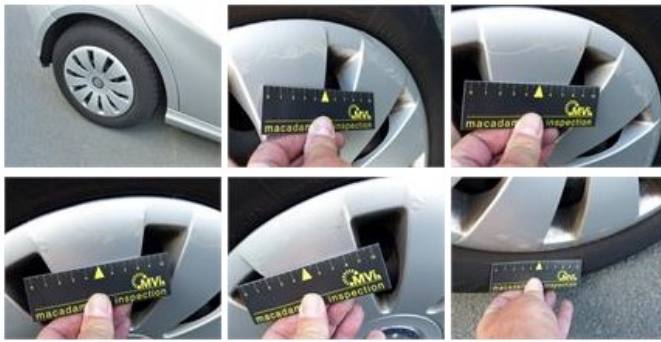
Wheel cover R R, Scratch(es), E - Replace 30,00

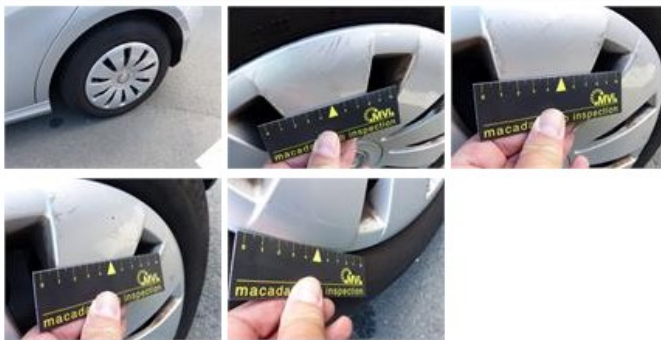
Wheel cover R L, Scratch(es), E - Replace 30,00

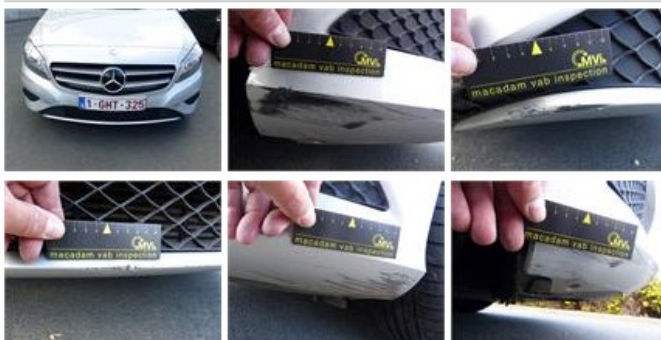
Bumper F, Scratch(es), LI - Repair and paint (complete) 211,80

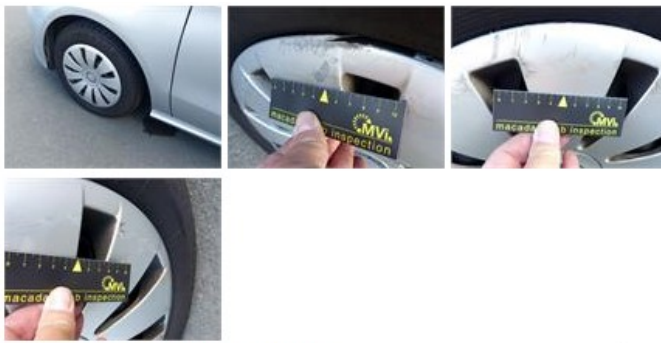
Wheel cover F L, Broken, E - Replace 30,00
