BMW 5: 1HSK674

Limited Technical Inspection

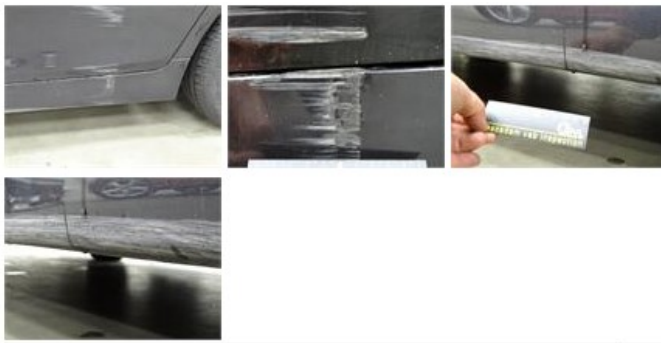
Sill outer L, Scratch(es), LI - Repair and paint (complete)	0,00
---	-------------

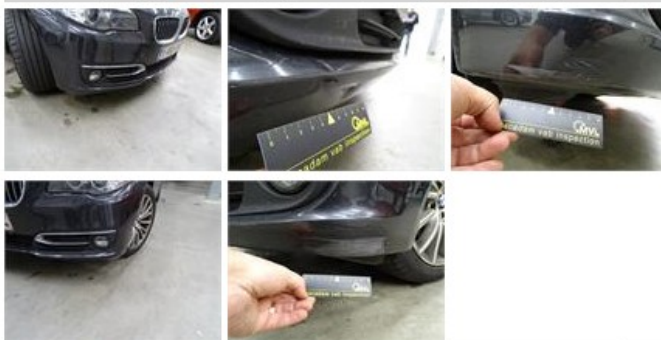
Bumper F, Dent(s) and scratch(es), LI - Repair and paint (complete) 326,16

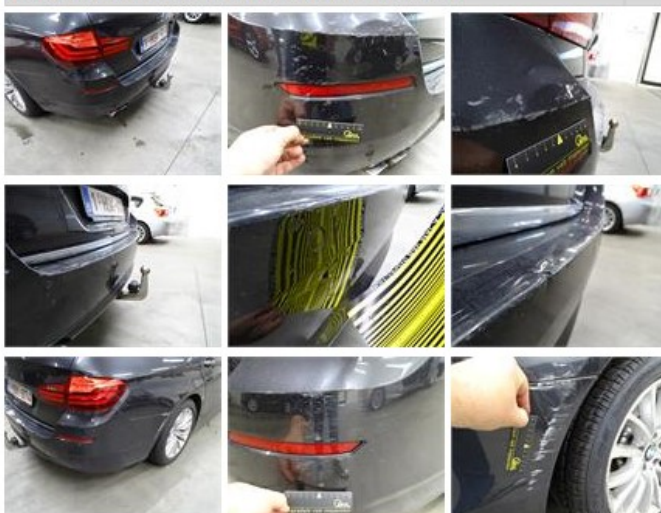
Bumper R, Deformed / Strained, Le - Replace and paint 0,00
