**VOLKSWAGEN Golf: 1FRV695**

**Limited Technical Inspection**

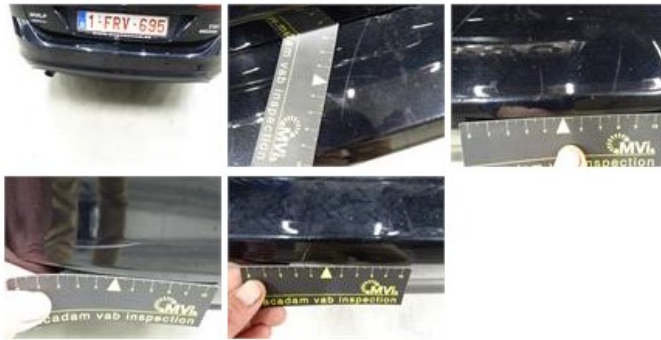
Bumper R, Scratch(es), LI - Repair and paint (complete) 211,80
