| AUDI A1 SPORTBACK: 1PXN619 | | | |
| Vinnumber: | WAUZZZ8X5HB031888 | Versionname: | 1.4 TDI 66kW |

| Limited Technical Inspection | | | |

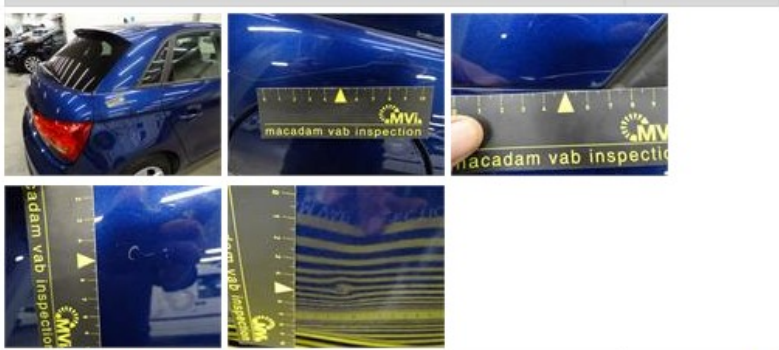
| Assistance equipment | | | |
|---|---|---|---|
| Wing R R, Scratch(es), LI - Repair and paint (complete) | | | 246,56 |

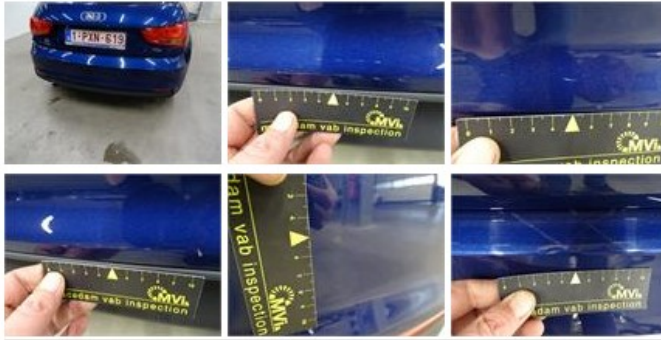
Bumper R, Scratch(es), LI - Repair and paint (complete) 169,44
