BMW 3: 1GGZ984

| Vinnumber: | WBA3Y11090D375921 | Versionname: | 3 GRAN TURISMO 318dA |

Limited Technical Inspection

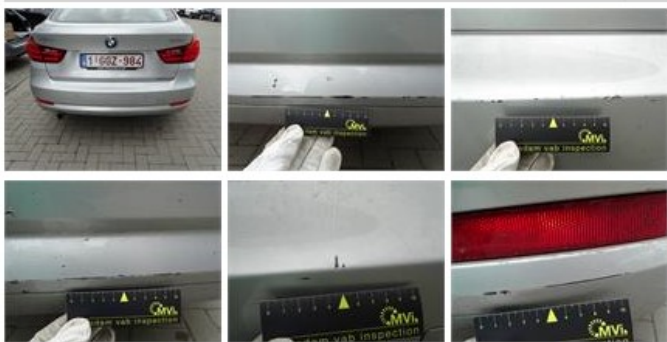
Bumper R, Scratch(es), LI - Repair and paint (partial) 220,00
