VOLKSWAGEN Golf: 1GA1053

Limited Technical Inspection

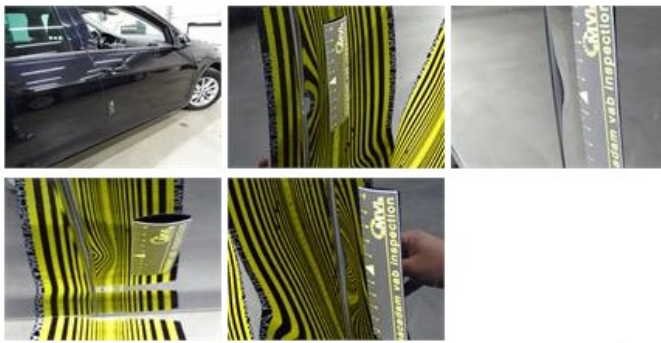
Door F R, Dent(s), LI - Repair and paint (complete)	318,35
---	--------

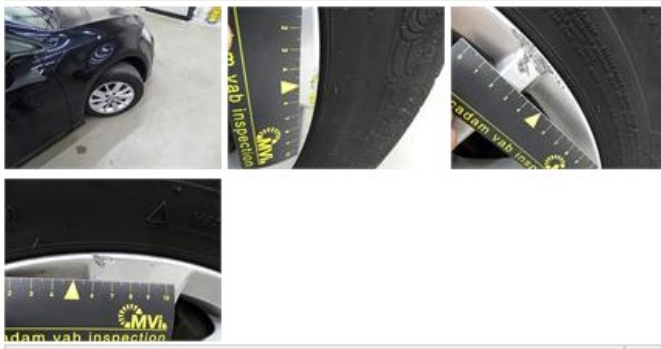
Alloy rim F R, Scratch(es), LI - Repair and paint (complete) 95,00

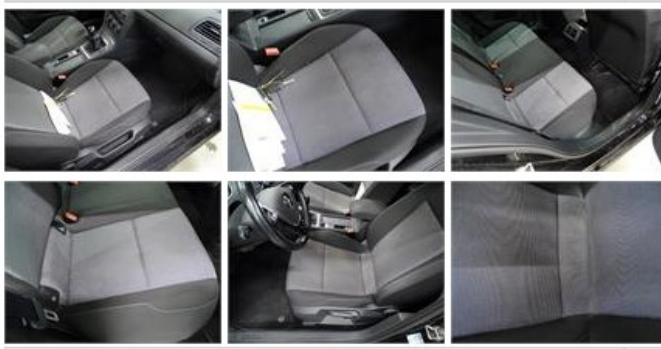
Interior, Stain, Cleaning 75,00
