BMW 5: 1HUJ503

Limited Technical Inspection

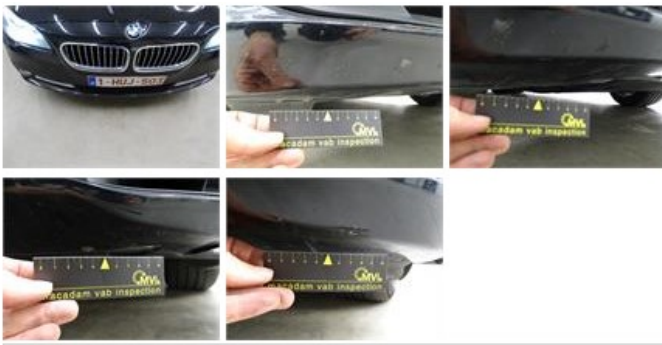
Bumper F, Scratch(es), LI - Repair and paint (complete)	0,00
---	-------------

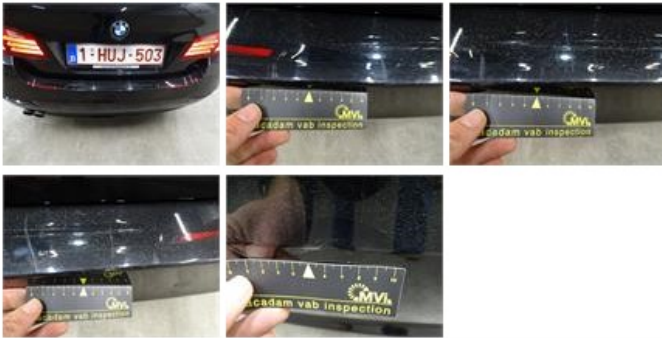
Bumper R, Scratch(es), LI - Repair and paint (complete) 0,00
