**BMW X3: 1SXA879**

**Limited Technical Inspection**

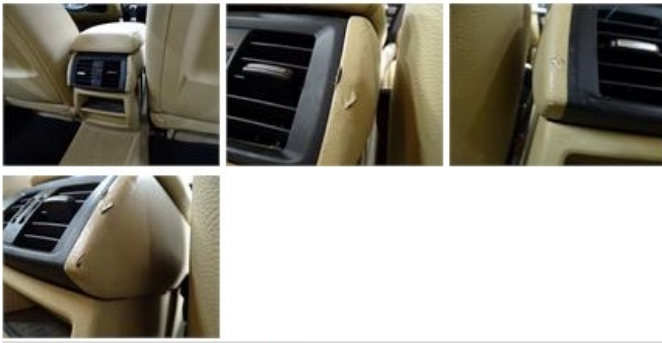
Centre console, Tear, E - Replace	<b>313,00</b>
-----------------------------------	---------------

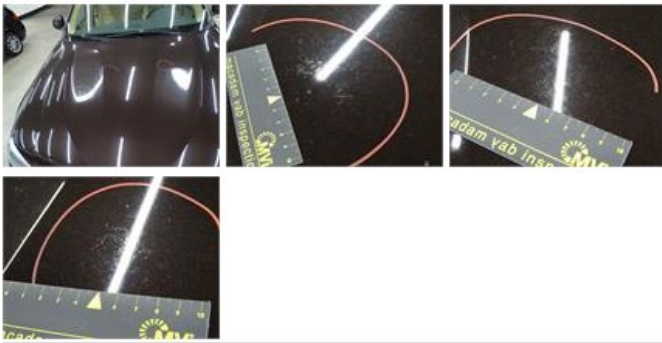
Bonnet, Chemical pollution, LI - Repair and paint (complete) 254,16
