**TOYOTA AURIS: 1NRF546**

**Limited Technical Inspection**

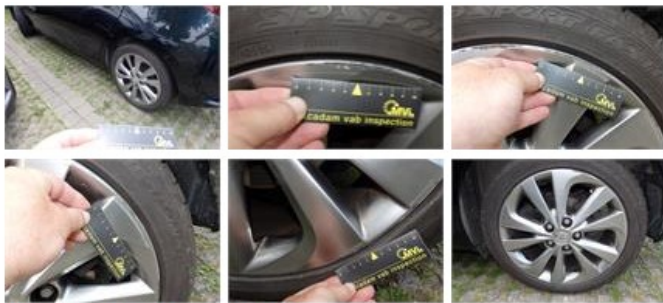
Total cost ex VAT	984,00
Boot cover, Scratch(es), Acceptable	0,00
<i>No pictures to display</i>	
Alloy rim R L, Scratch(es), LI - Repair and paint (complete)	95,00

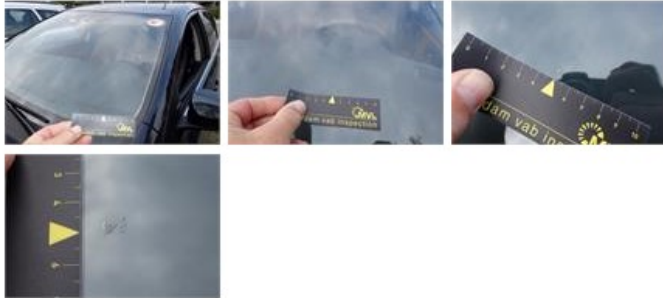
Windscreen, Broken, E - Replace 487,20

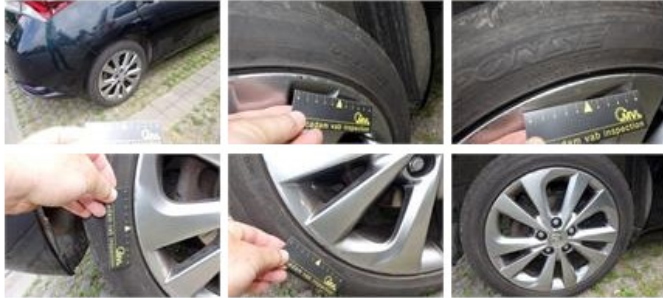
Alloy rim R R, Scratch(es), LI - Repair and paint (complete) 95,00

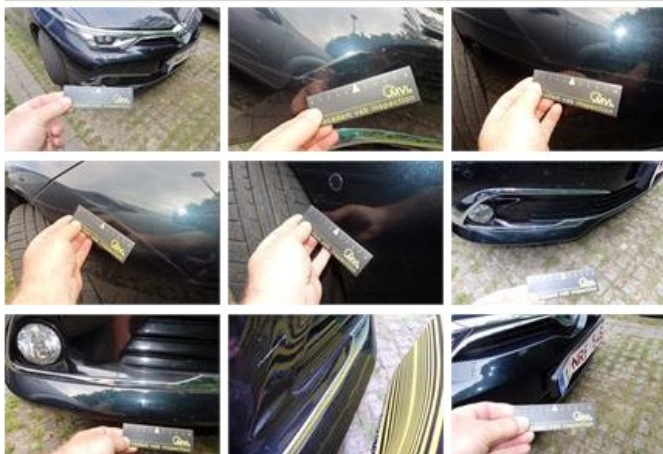
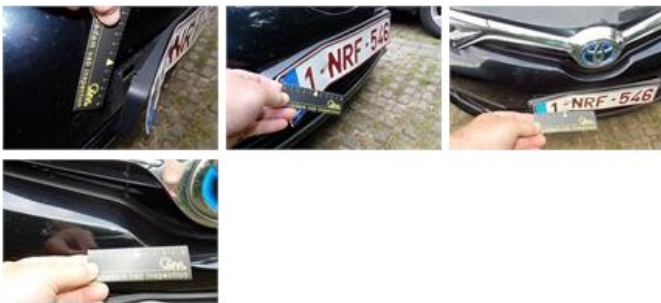
Bumper F, Dent(s) and scratch(es), LI - Repair and paint (complete) 211,80

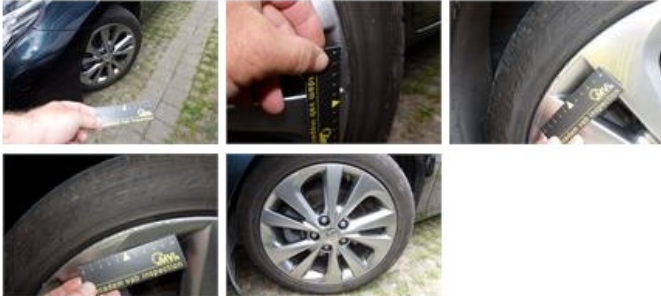
Alloy rim F L, Scratch(es), LI - Repair and paint (complete)	95,00
--	-------
