FORD Grand C-Max: 1FCT497

Limited Technical Inspection

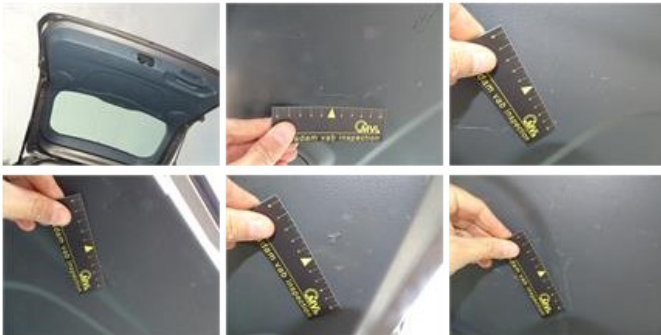
Rear Panel Internal Lining, Scratch(es), E - Replace 118,40
