BMW 5: 1FQQ415

Limited Technical Inspection

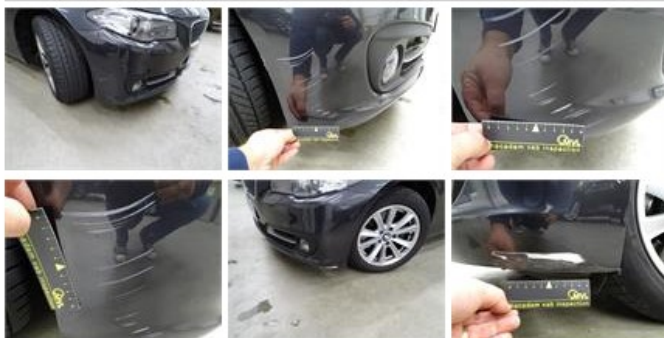
Bumper F, Scratch(es), LI - Repair and paint (complete)

254,16

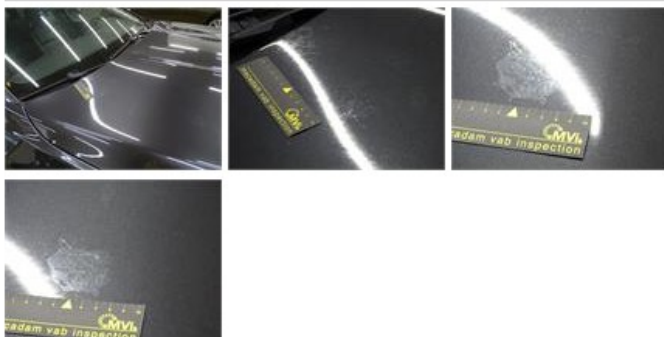
Bonnet, Chemical polution, LI - Repair and paint (complete)

348,09

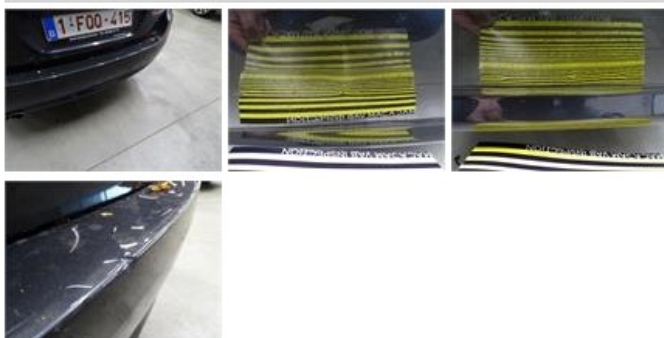
Bumper R, Dent(s) and scratch(es), LI - Repair and paint (complete)

350,16

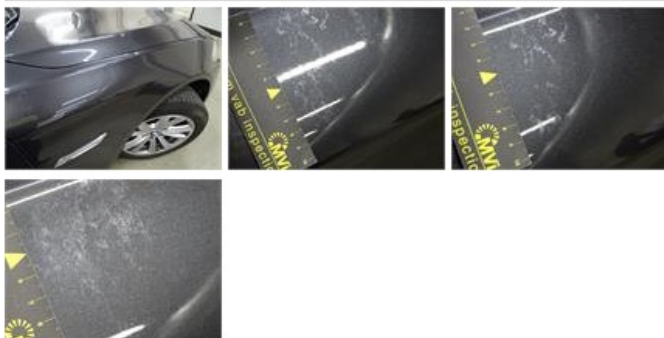
Wing F R, Chemical polution, LI - Repair and paint (complete)

264,21
