HYUNDAI IONIQ: 1TJG411

Limited Technical Inspection

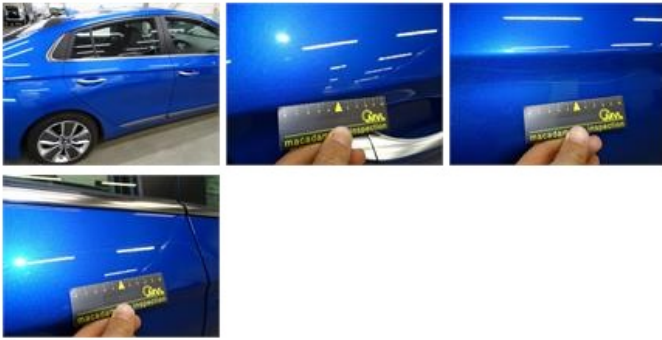
Door R R, Scratch(es), LI - Repair and paint (complete)
